Manhole Inspection Summary

Manhole # S25AA1019MH

Insp Date: **1/29/07 9:08 AM**

Location Address: **3600 FALLS RD**

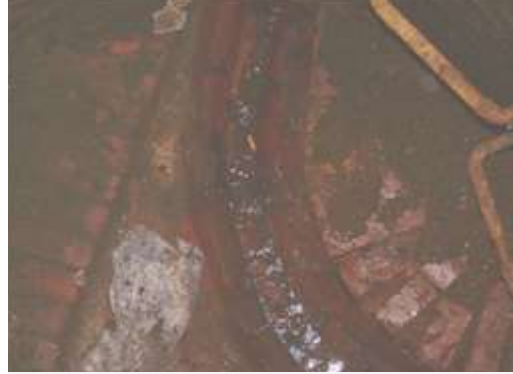
Top View

☐ Parged ☒ **Debris** (not Condition related)

Steps Count: **5** Missing: **0** ☒ **Corroded**

Corroded steps. Bench debris.

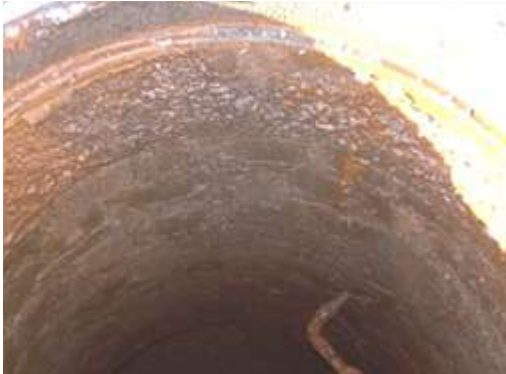
Defect

☒ **Leaks**

Infiltration: ☐ None ☒ **Joint** ☐ Cracks ☐ Mortar ☐ Roots ☒ **Wall**

Frame leaks. Adjustment infiltration.

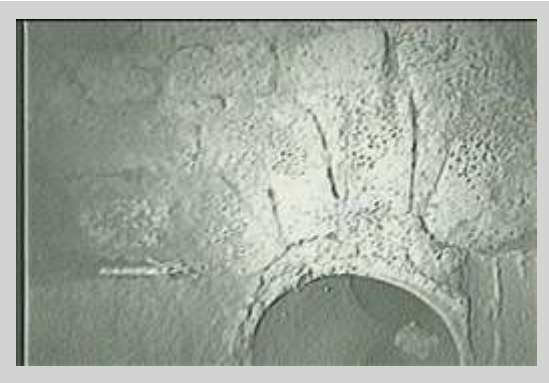
8 in. Circular Gravity Sewer Pipe Out @ 12 O'Clock

Infiltration: **Evidence** Pipe Seal Cond: **Cracked**

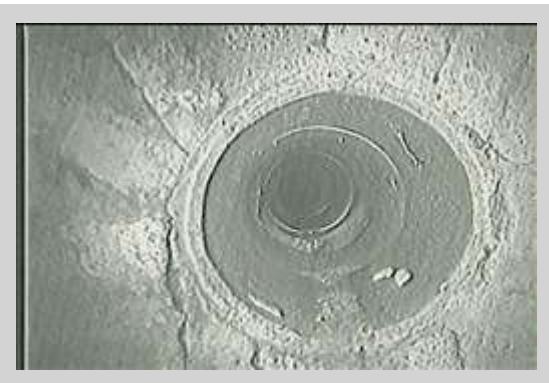
8 in. Circular Gravity Sewer Pipe In @ 4 O'Clock

Infiltration: **None** Pipe Seal Cond: **Unknown**

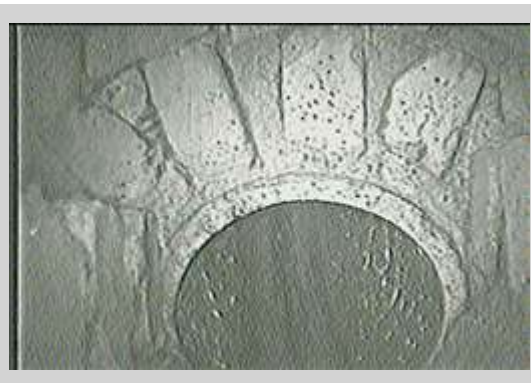
Drop In @ 4 O'Clock

Drop: **Outside** Rod and Bar

Drop Condition: **Open**
